ST. ANTHONY  
FALLS LABORATORY

**Project Report No. 576**

***Assessing Iron-Enhanced Swales for  
Pollution Prevention***

Final Report

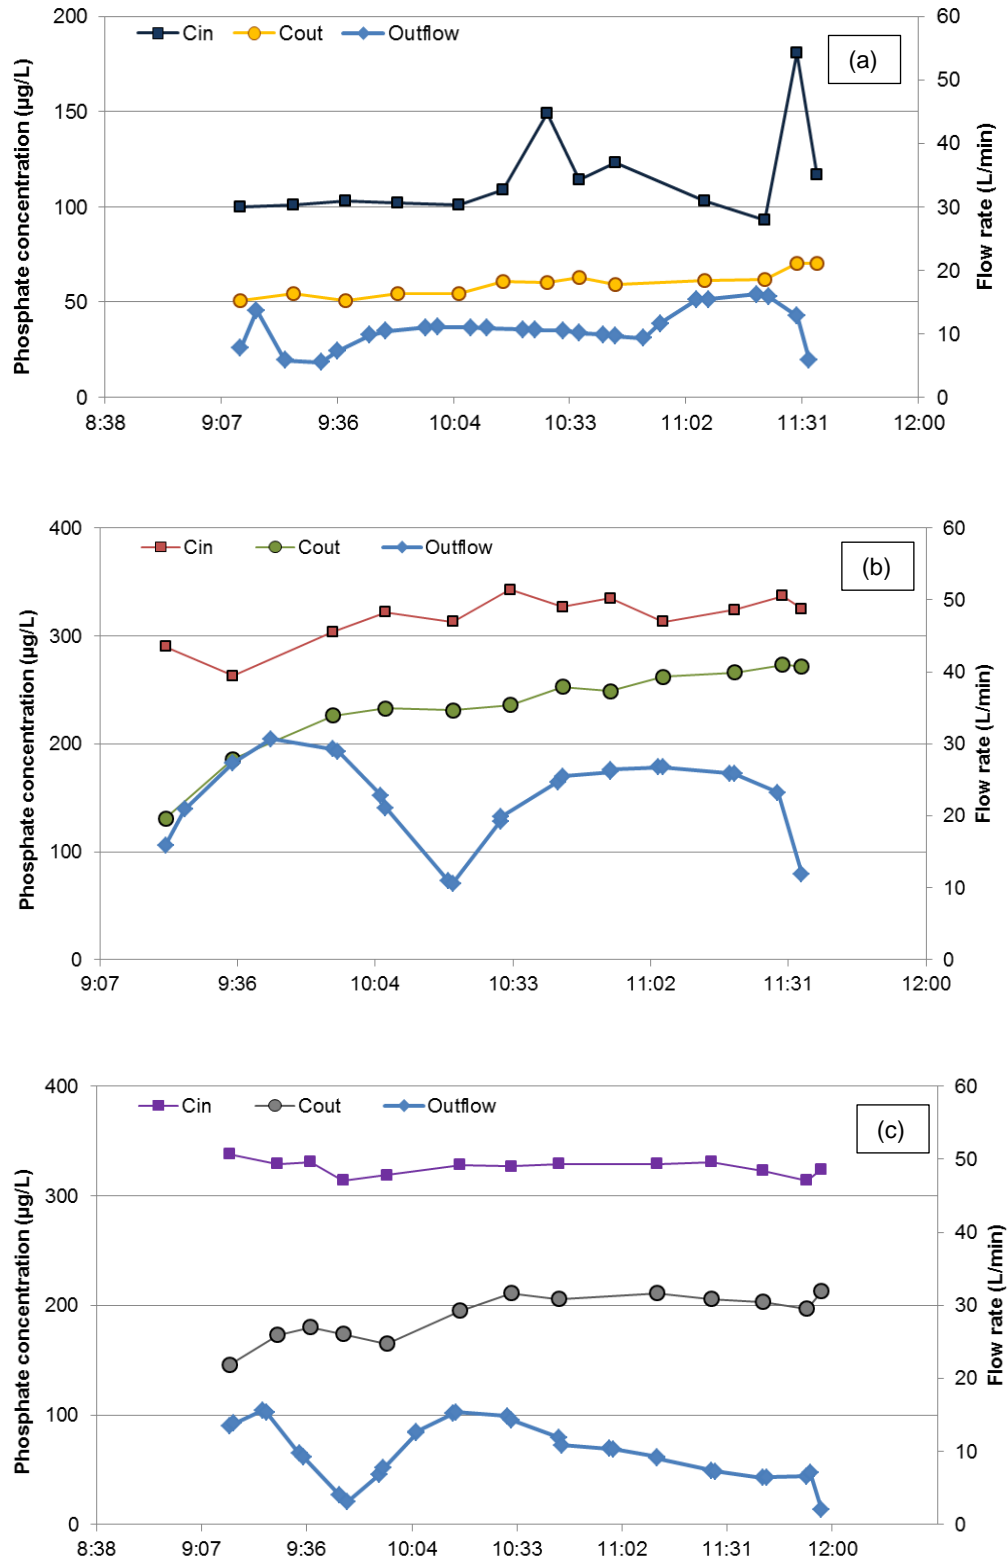
**Figure 22. Results of field testing conducted at the re-installed Roseville ditch check in summer 2015: (a) Test 1 on July 24; (b) Test 2 on August 7; and (c) Test 3 on August 14, 2015. Cin and Cout denote concentration in the inflow and filter outflow.**

Performance of the ditch check in retaining dissolved metals was determined for the first field test conducted in July 24, 2015. The mean metal concentration in the influent was 25  $\mu\text{g/L}$  Zn and 1.3  $\mu\text{g/L}$  Pb. The effluent contained 21  $\mu\text{g/L}$  Zn and 1.4  $\mu\text{g/L}$  Pb. The ditch check retained about 14% of the zinc load input, but lead was not removed. The low metal retention capability was observed at the MnDOT monitoring site as well. It is possible that the adsorption of metals requires a longer contact time with the filter media (when compared to phosphate), and thus results in low overall removal.

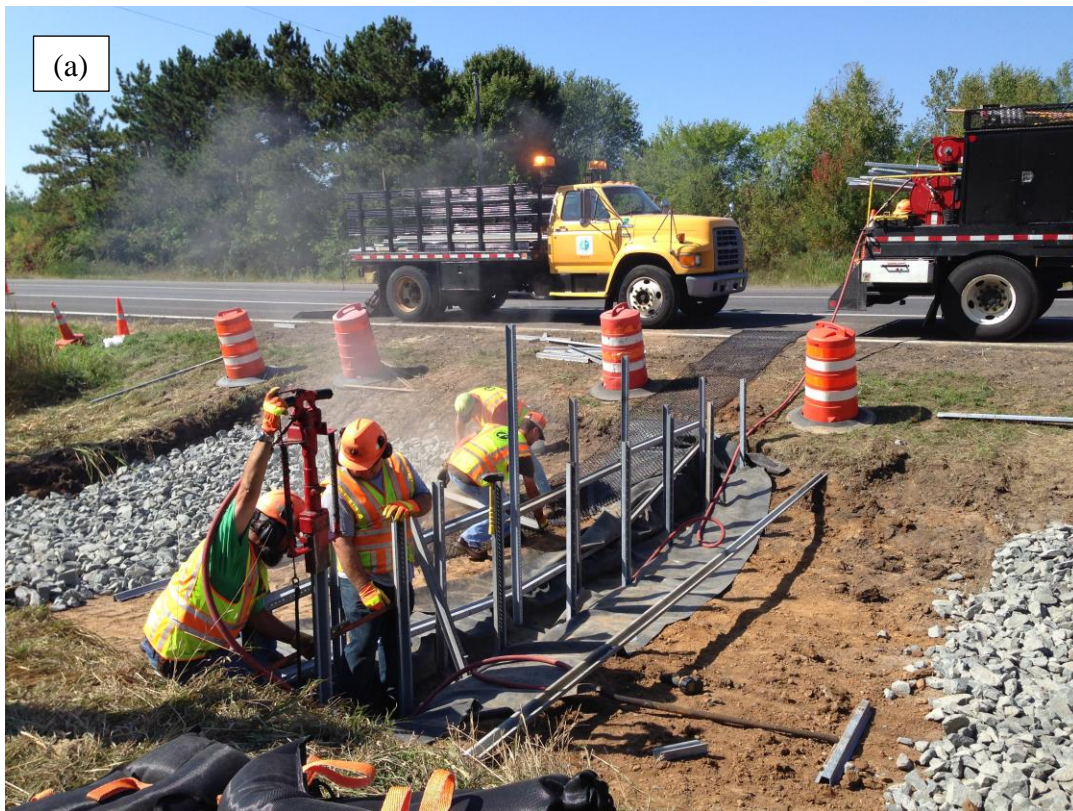
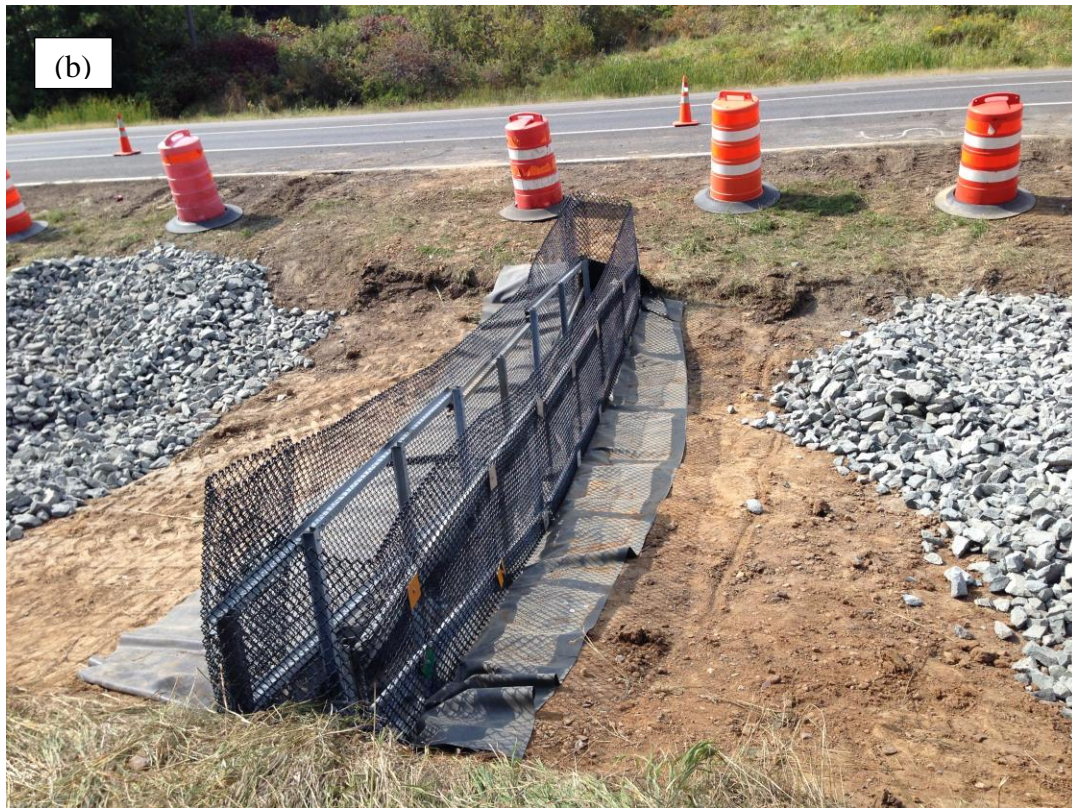
**Figure A- 2. (a) Construction stage showing the filter cage enclosure. (b) Completed filter cage enclosure at ditch check site 1.**

The existing ditch checks were dug out completely at site 1 and site 2 at the MnDOT swales along TH5, Stillwater. A trench was dug (sub-cut) below the normal grade (trench width = 0.5 m (18 inch); depth ranged from 10 cm (4 inch) at middle to 30 cm (12 inch) at sides) across the ditch cross-section (i.e. perpendicular to the direction of flow). The sub-cut, lined with an impermeable liner, was provided to place the first layer of filter bags just below the normal ditch bottom for preventing flow seeping below the filter. A filter cage was built around the trench to contain the filter bags; PVC-coated chain link fencing was tied around vertical sign posts that were braced at the top, bottom, and laterally to form the filter cage assembly (Figure A- 2). The bottom of the sign post conformed to the ditch side slope and bottom, and the top of the post was cut to be at least 7.6 cm (3 inch) below the finished grade.

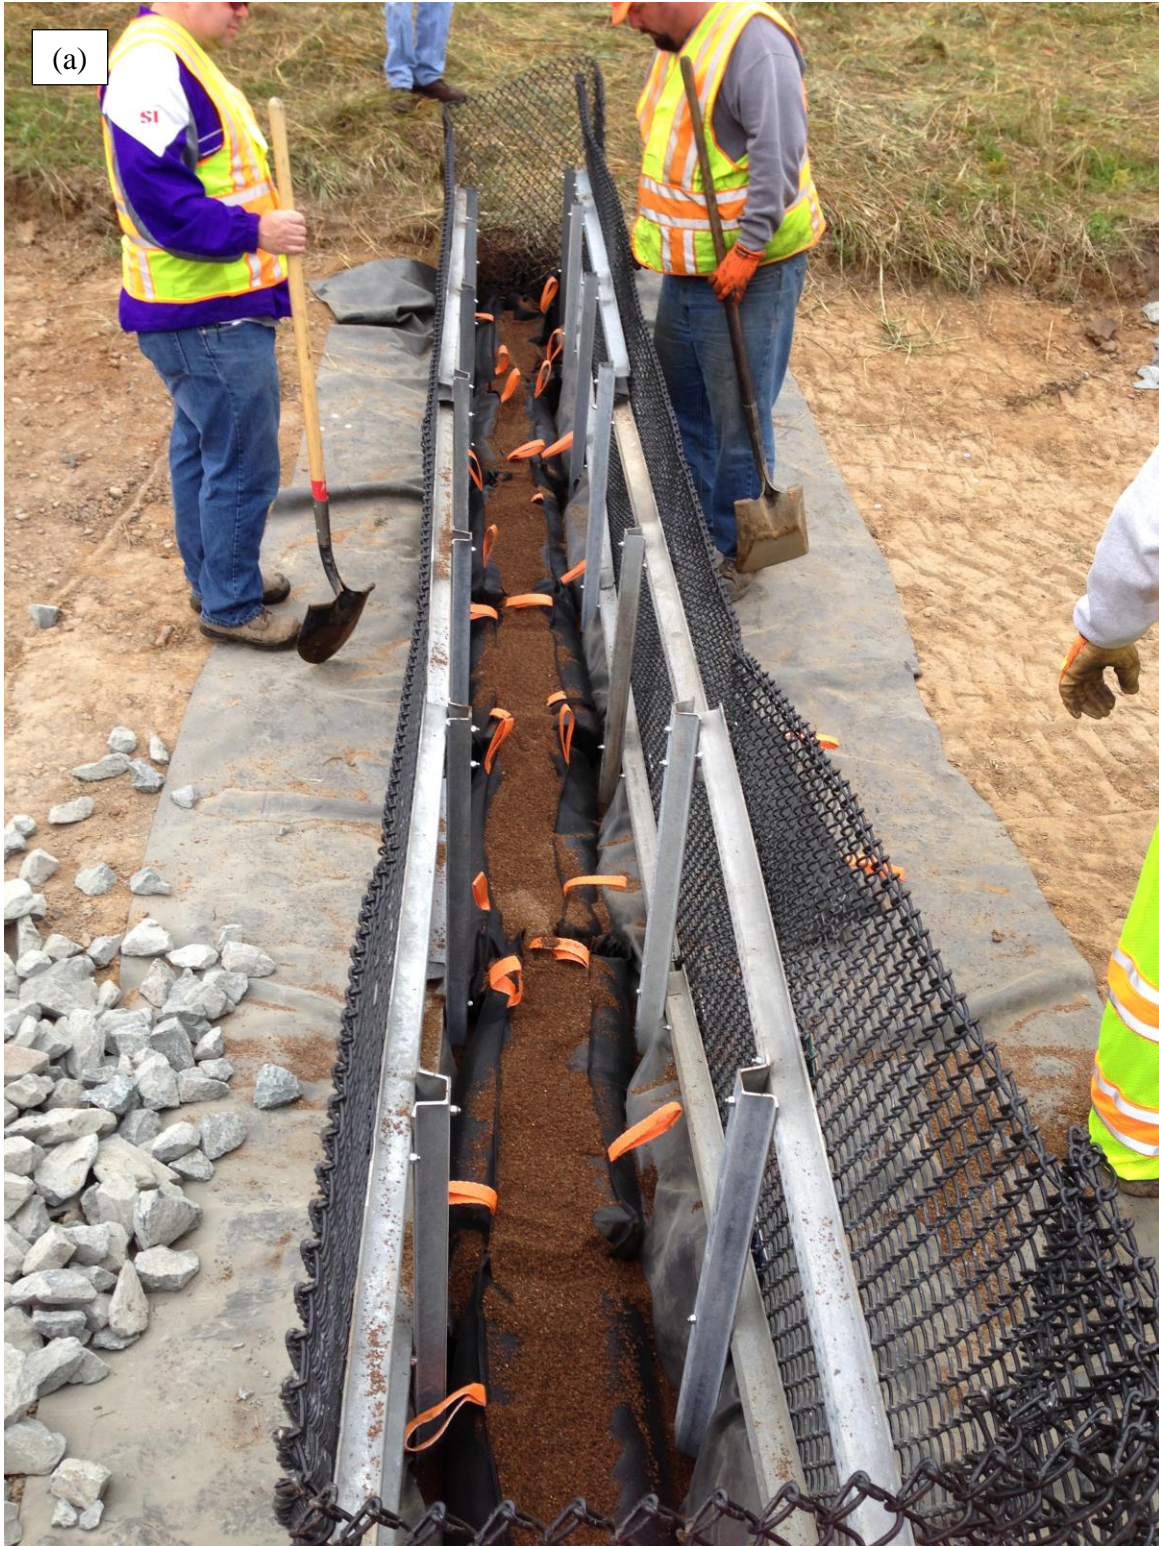
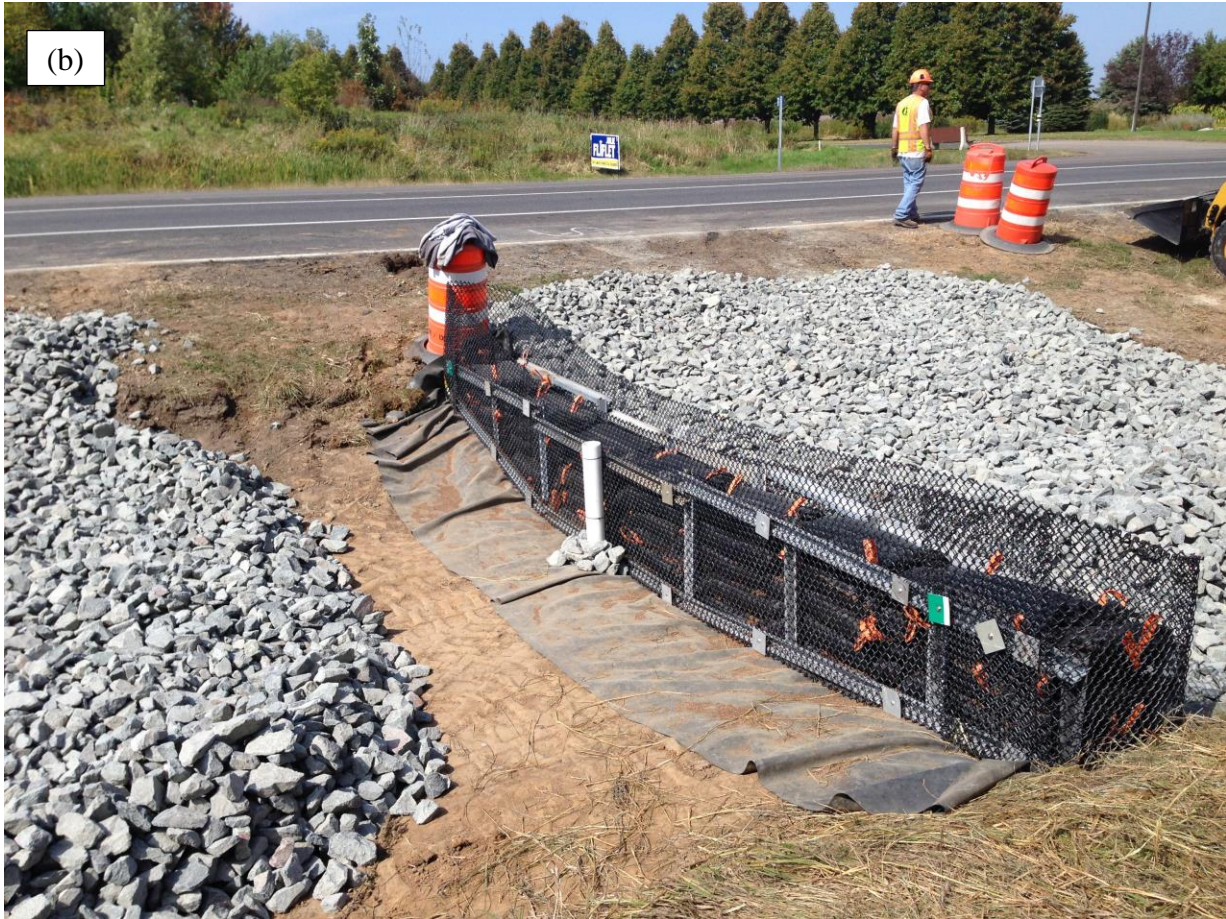
**Figure A- 3. (a) Construction stage showing the placement of filter bags and filling media within the filter cage enclosure. (b) Completed filter installation at ditch check site 1.**

After placing a layer of 5 cm (2 inch) approximate depth of loose filter media in the trench, the first layer of filter bags were placed in two rows, along the entire width of the trench (transverse to the flow direction). The space between the filter bags, corners, and top of the bag layer were filled with loose media before placing the next layer of bags (Figure A- 3a). The process was repeated until the filter cage was filled with the filter bags (Figure A- 3b). The open spaces in the cage were filled with loose media throughout the installation. The final filter size in the direction of flow was approximately 0.4 m (17 inch). The bags tended to flatten when stacked.

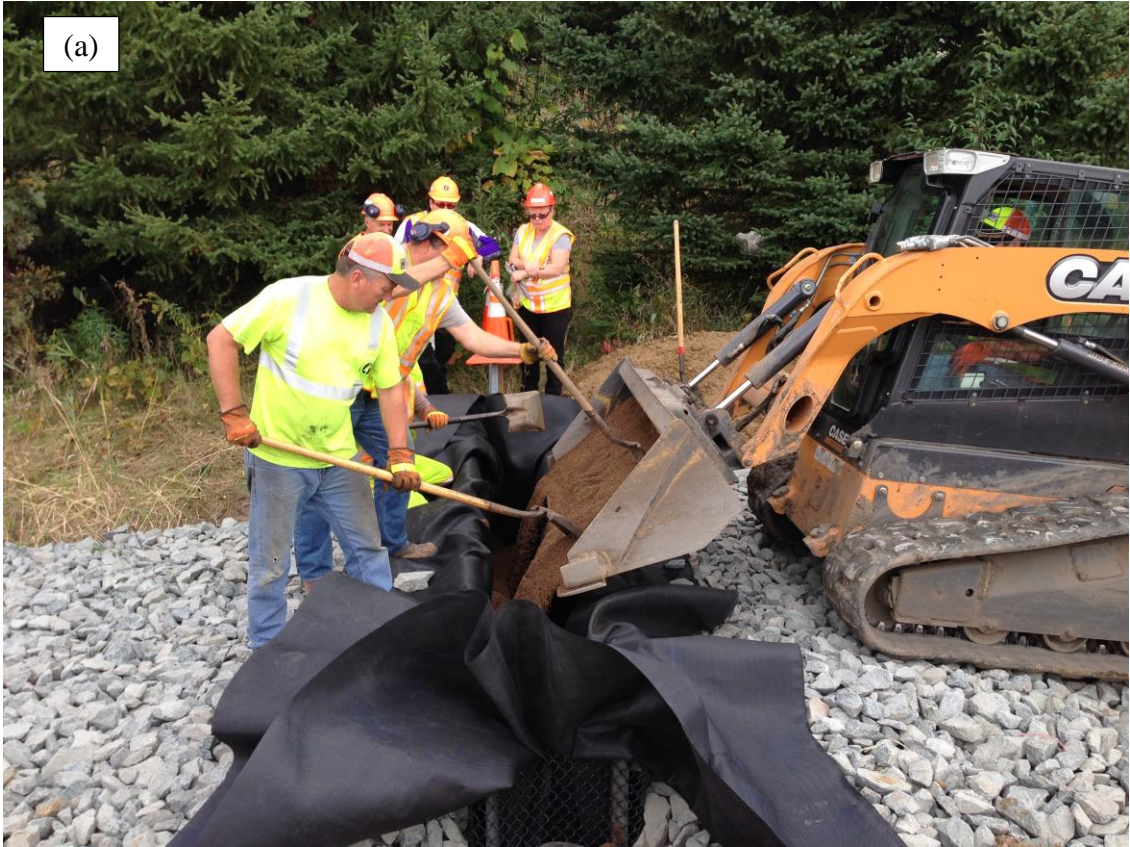
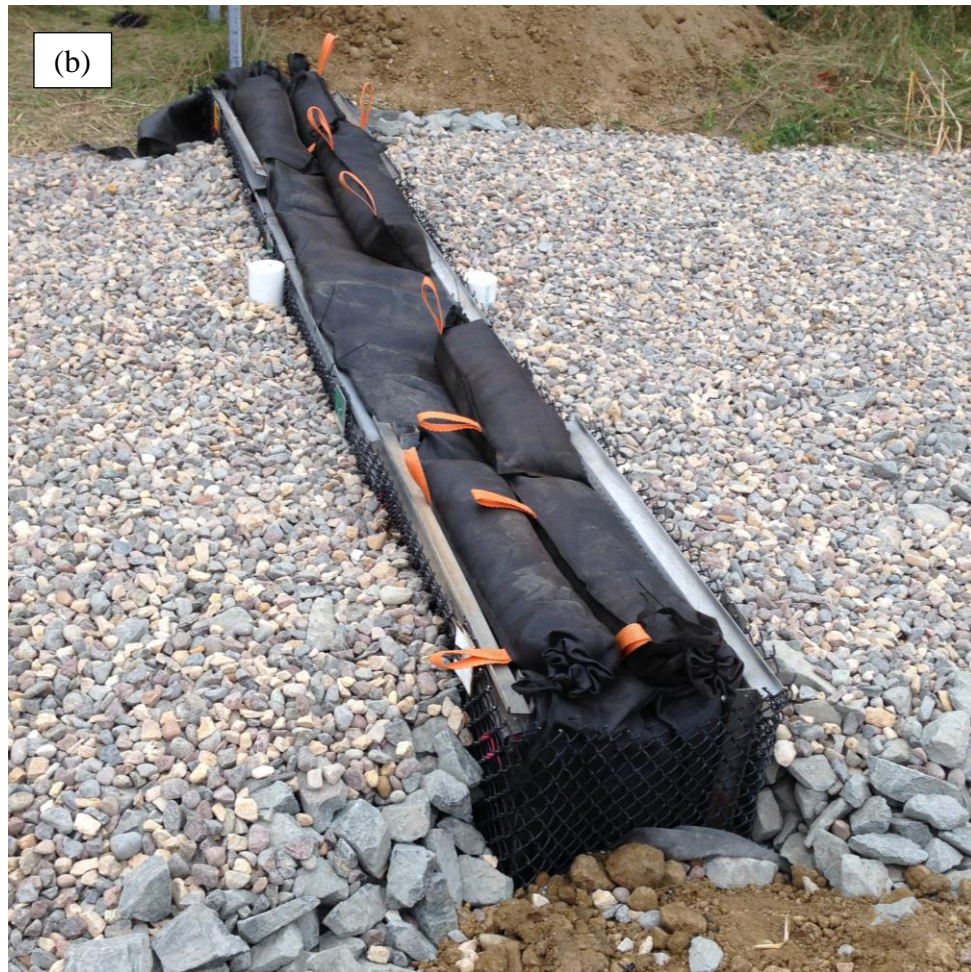
**Figure A- 4. (a) Construction stage showing placement of filter media into a single wrap-bag; (b) Completed filter at ditch check site 2, MnDOT swales.**

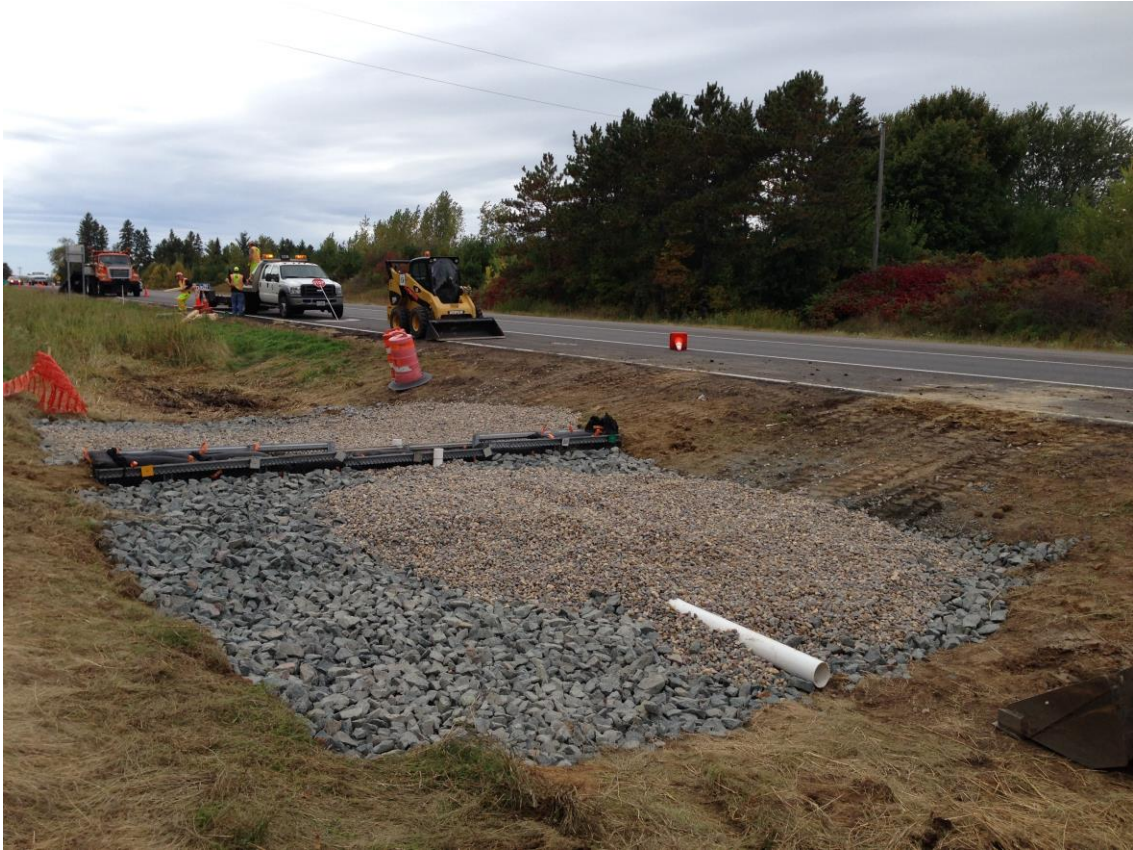
**Figure A- 5. Construction stage showing the rip rap and river rock layers placed around the filter cage, and drain tile on the downstream side at ditch check site 1, MnDOT swales.**

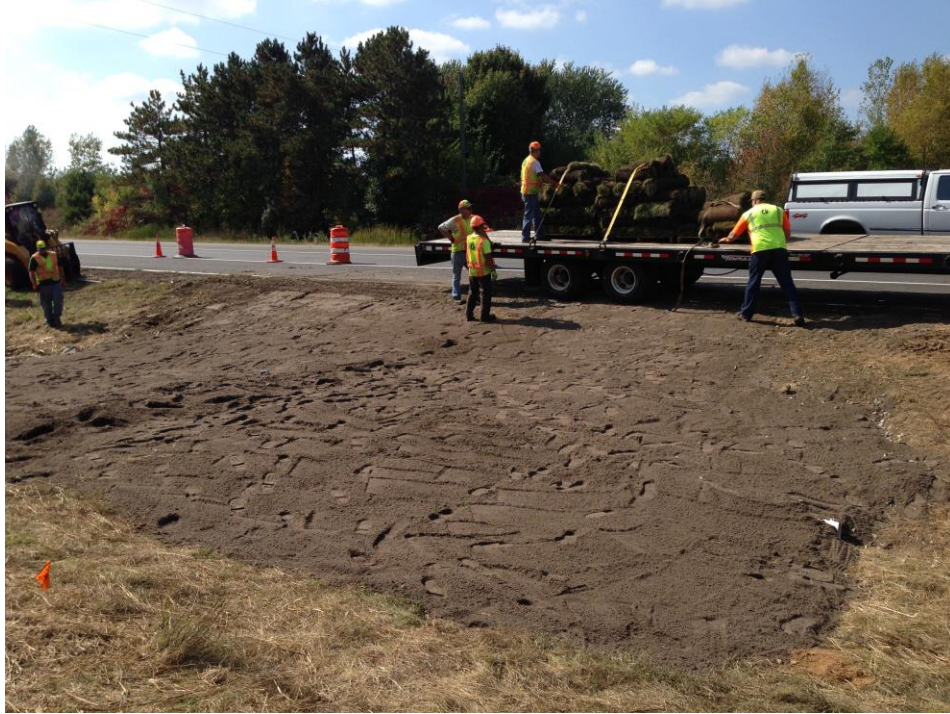
**Figure A- 6. Construction stage showing placement of top soil mix at ditch check site 1, MnDOT swales.**

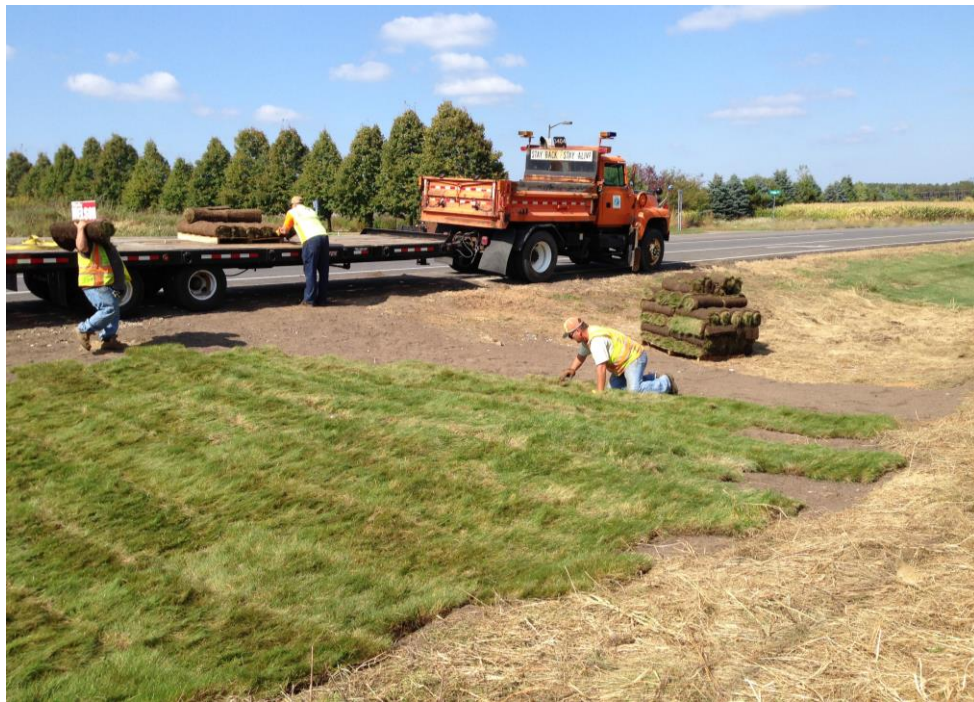
**Figure A- 7. Construction stage showing placement of sod at ditch check site 1, MnDOT swales.**

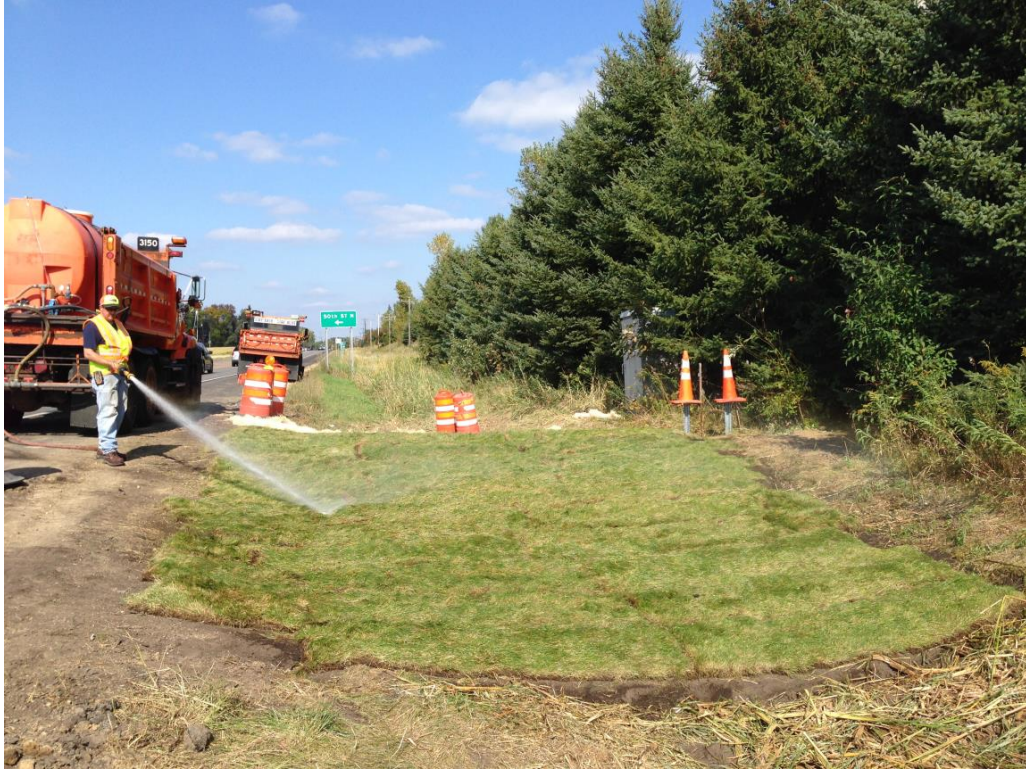
**Figure A- 8. Iron-enhanced ditch check constructed at site 2, MnDOT swales.**

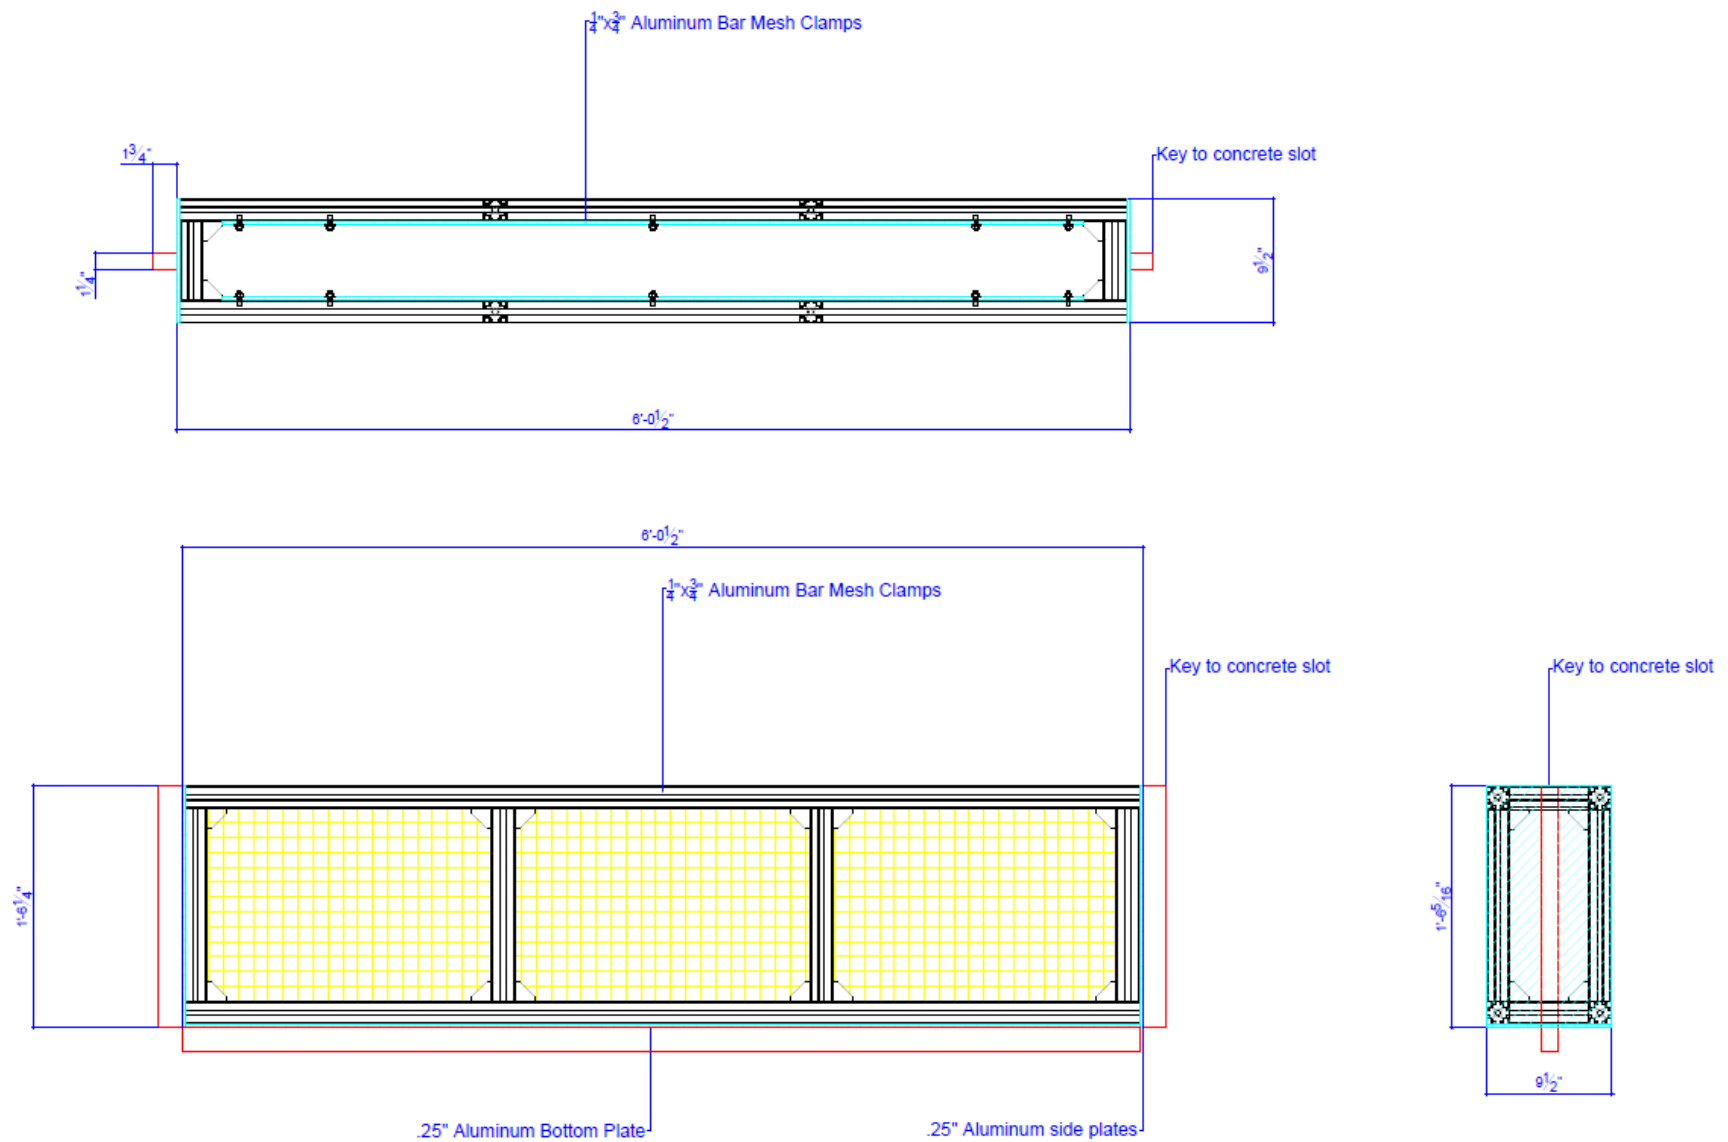
**Figure A- 9. Drawings of the aluminum filter enclosure designed at SAFL for the Roseville ditch check.**

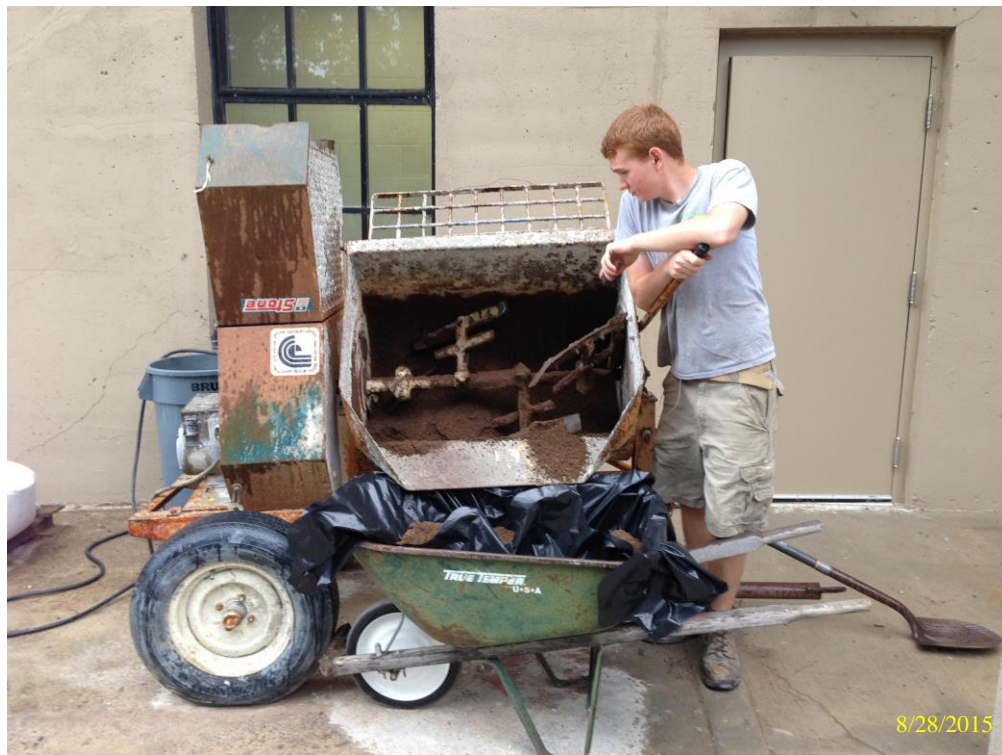
**Figure A- 10. Mixing of sand and iron shavings in a mortar mix.**

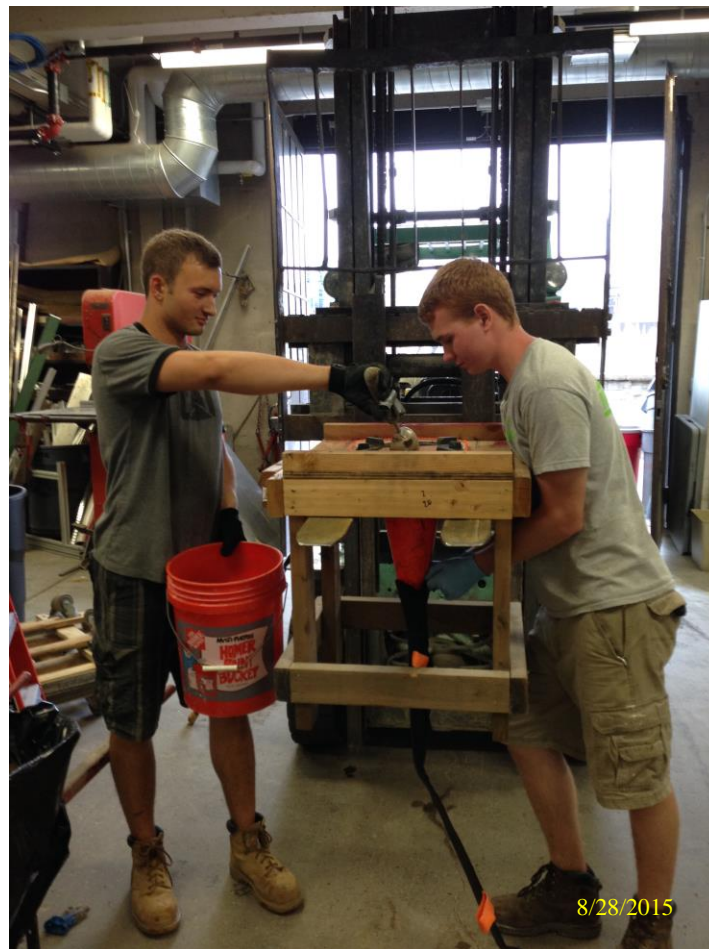
**Figure A- 11. Filling filter media mix into the filter socks using the funnel setup at SAFL.**

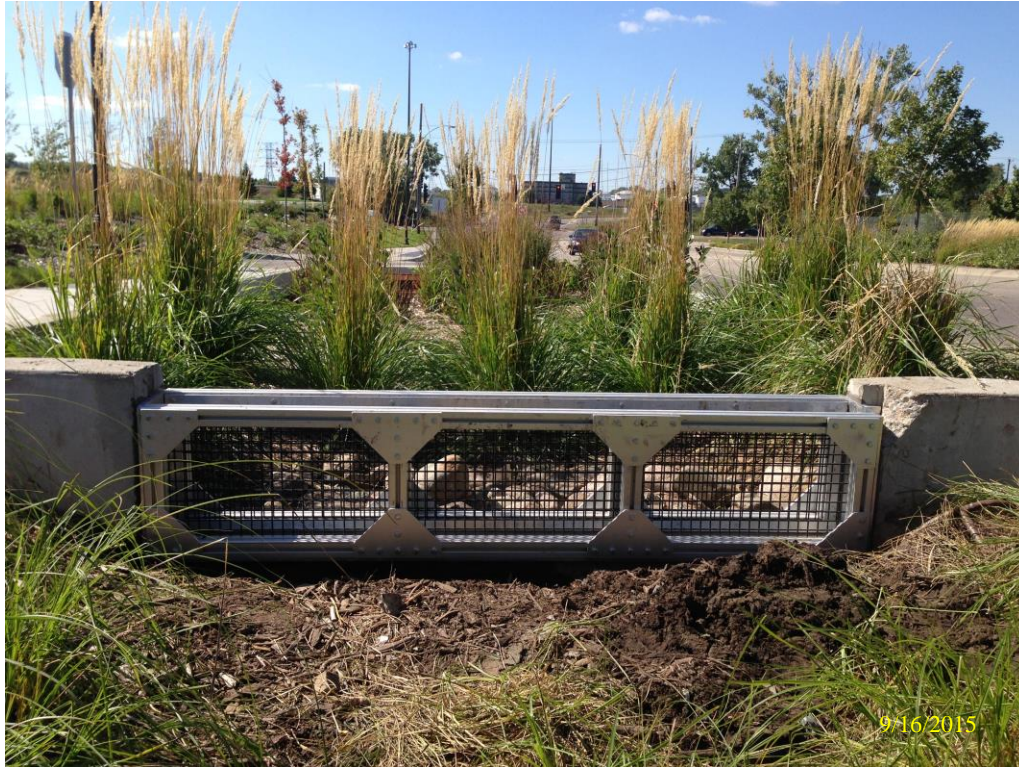
**Figure A- 12. Aluminum frame enclosure affixed in the concrete wall at the Roseville swale site.**

the enclosure were made water-tight by applying a silicone-based sealant, and the sealant was allowed to completely dry for one day.

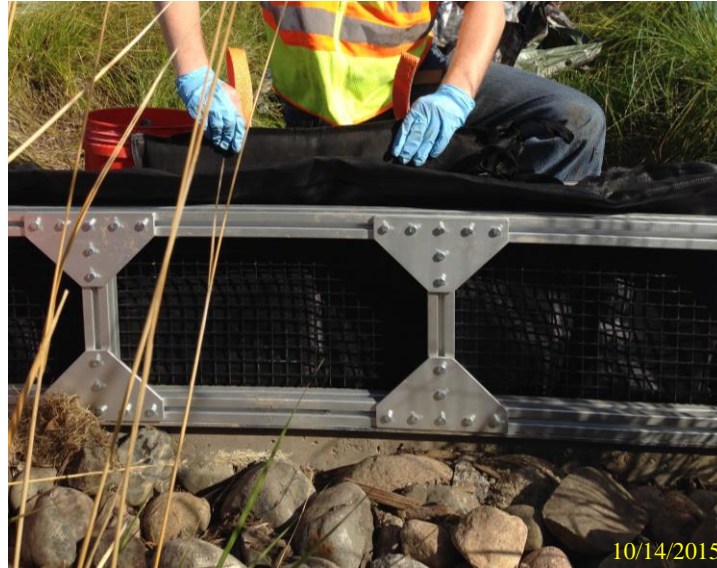
**Figure A- 13. Installation of filter socks within the frame enclosure at Roseville swales (first iron-enhanced ditch check installed in October 2014).**

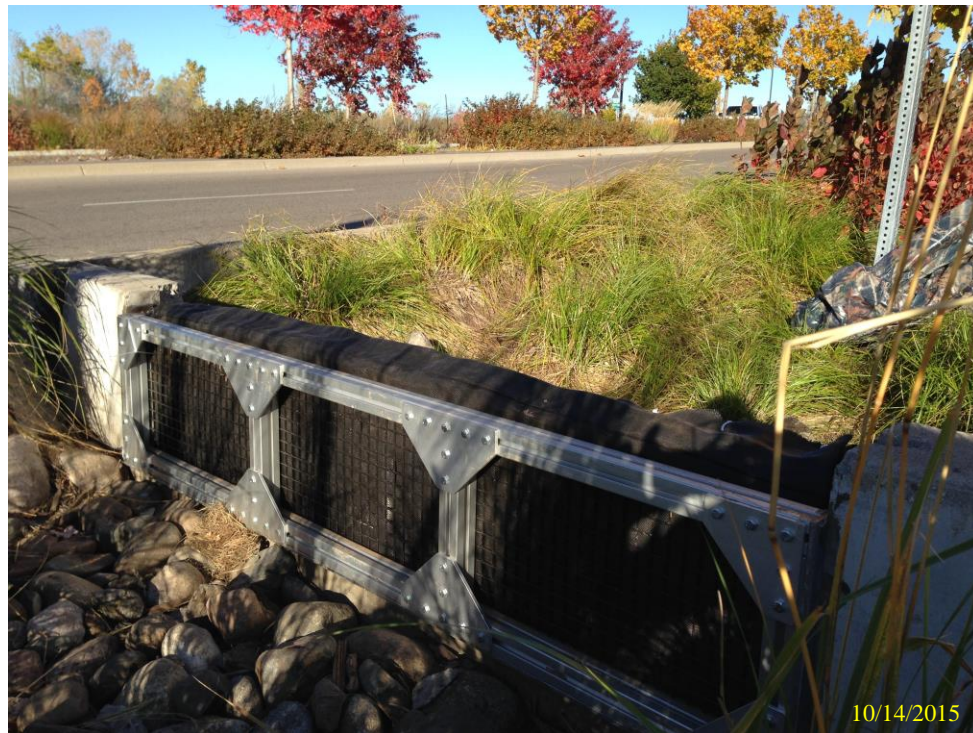
**Figure A- 14. Photograph of the completed Roseville iron-enhanced ditch check filter assembly taken in October 2014.**

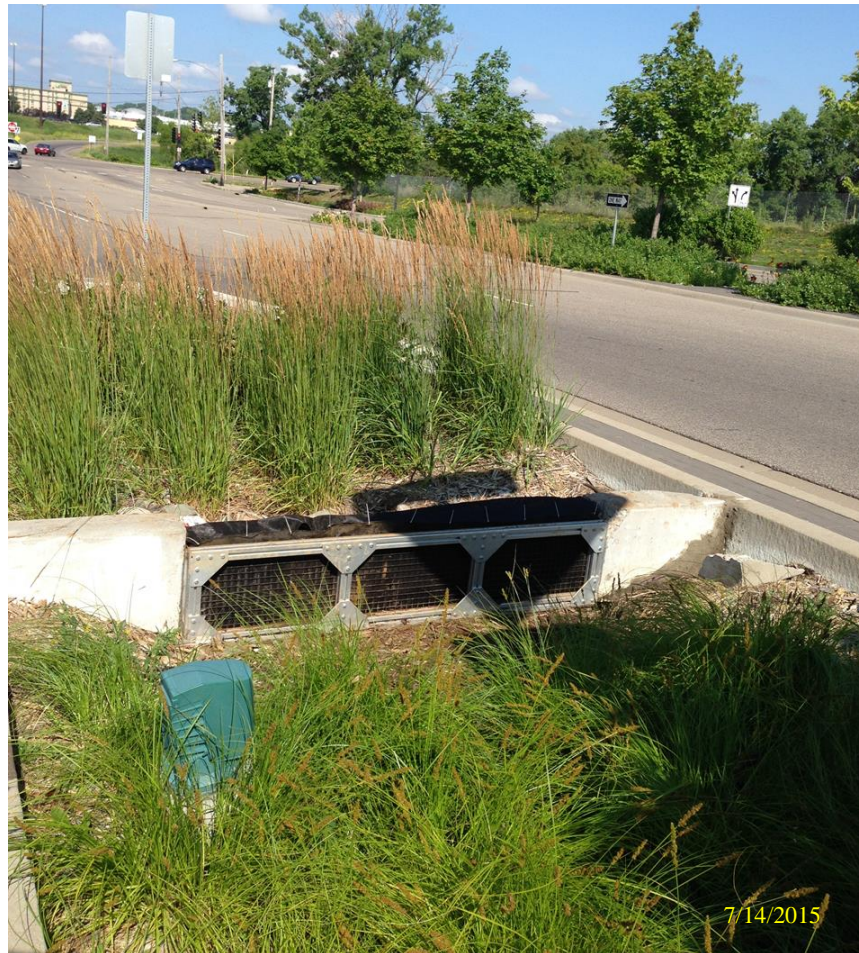
**Figure A- 15. Photograph of the re-installed iron-enhanced ditch check filter at Roseville swales site in July 2015.**

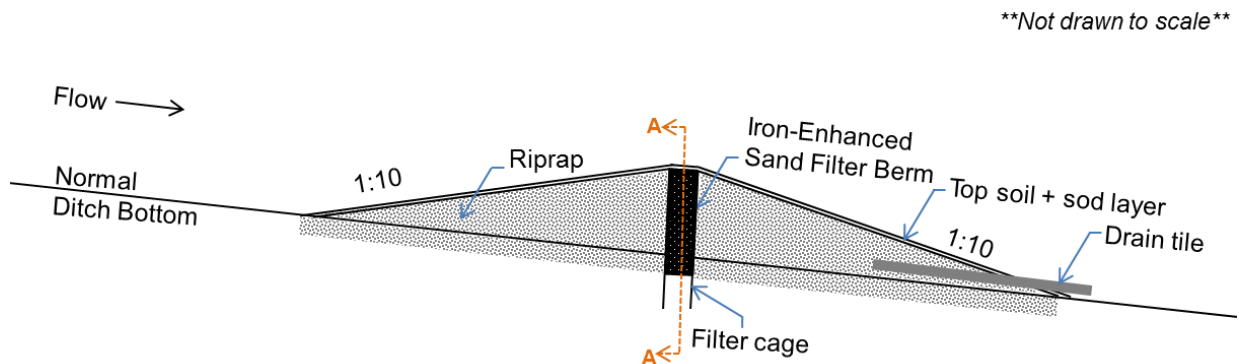
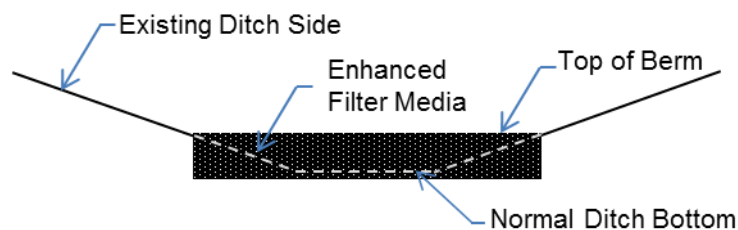
**Figure B- 1. Schematic of recommended design for a typical iron-enhanced swale ditch check. (a) Profile view and (b) Cross-sectional view (Section A-A).**

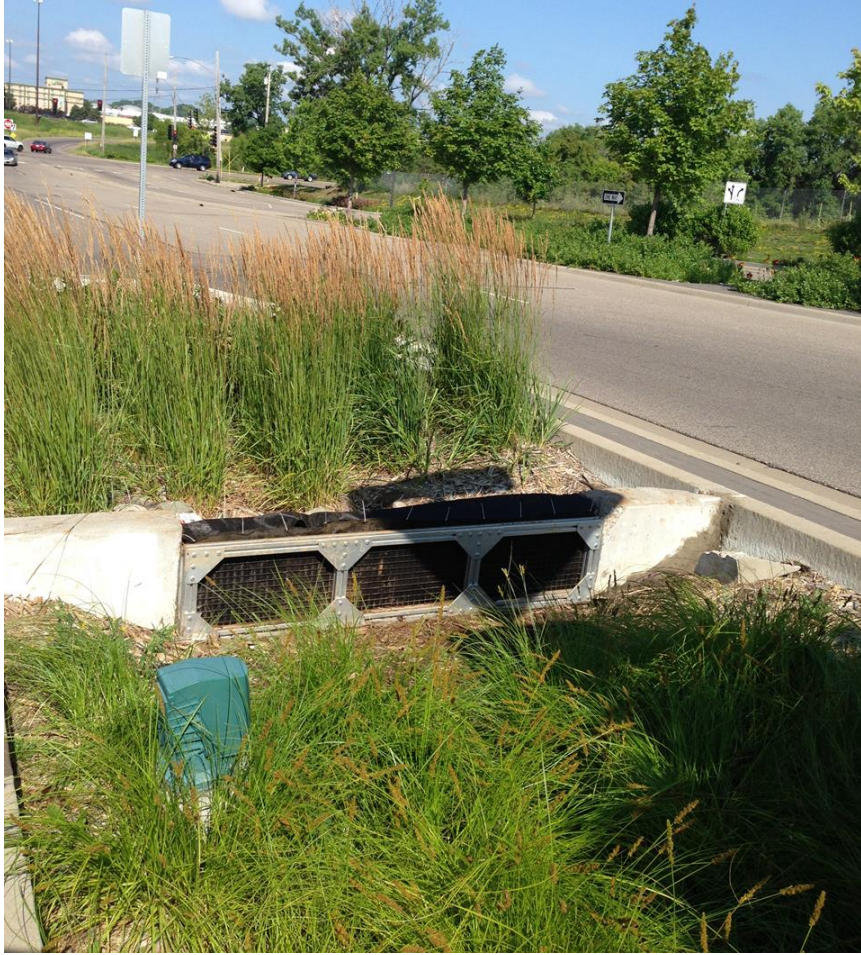
**Photograph of the iron-enhanced ditch check installed at the City of Roseville swales.**

As will be discussed later, water was observed to leak from one corner of the ditch check during field testing. Therefore, the ditch check was re-installed in July 2015 so that further tests could be conducted. In the new installation, the filter media was placed inside a single geotextile bag. The revision eliminated the multiple bag-design previously adopted. The filter media packed in the old individual bags was taken out and poured into a single geotextile bag inside the frame enclosure, and sealed at the top. Given the small size of the ditch check, the single-bag design is better as it reduces the amount of geotextile material needed. The final dimensions and appearance of the new ditch check filter were same as the first installation (photograph is provided in Appendix A).
